2 施工資料

3) 工事写真

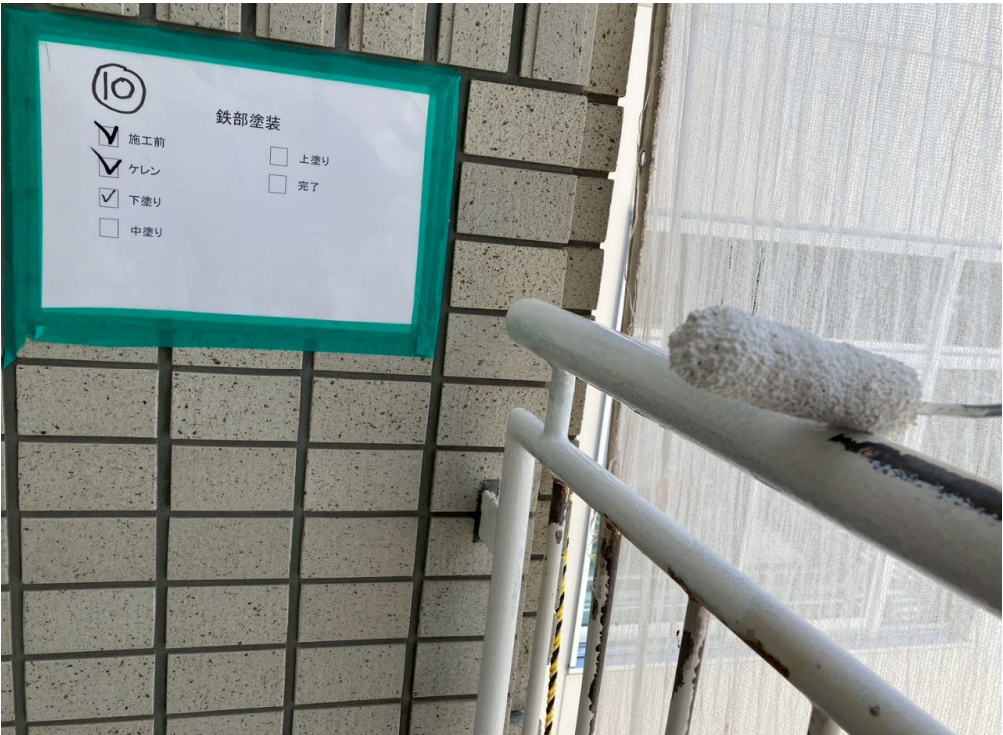
南面⑦	3	鉄柵部塗装	下塗

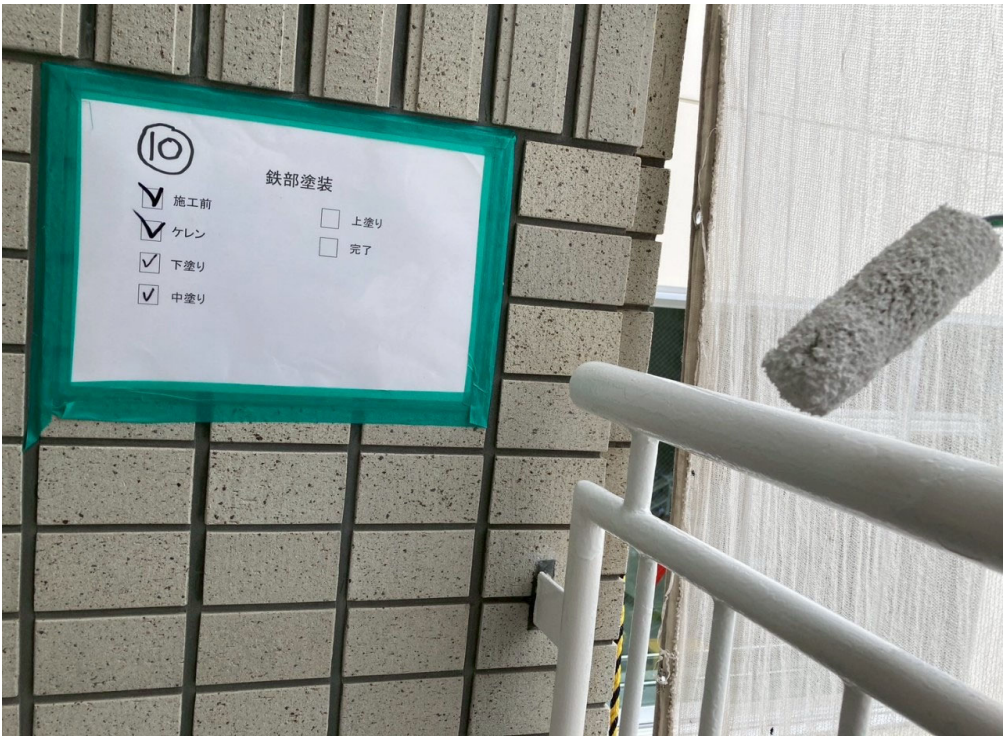
南面⑦	4	鉄柵部塗装	中塗

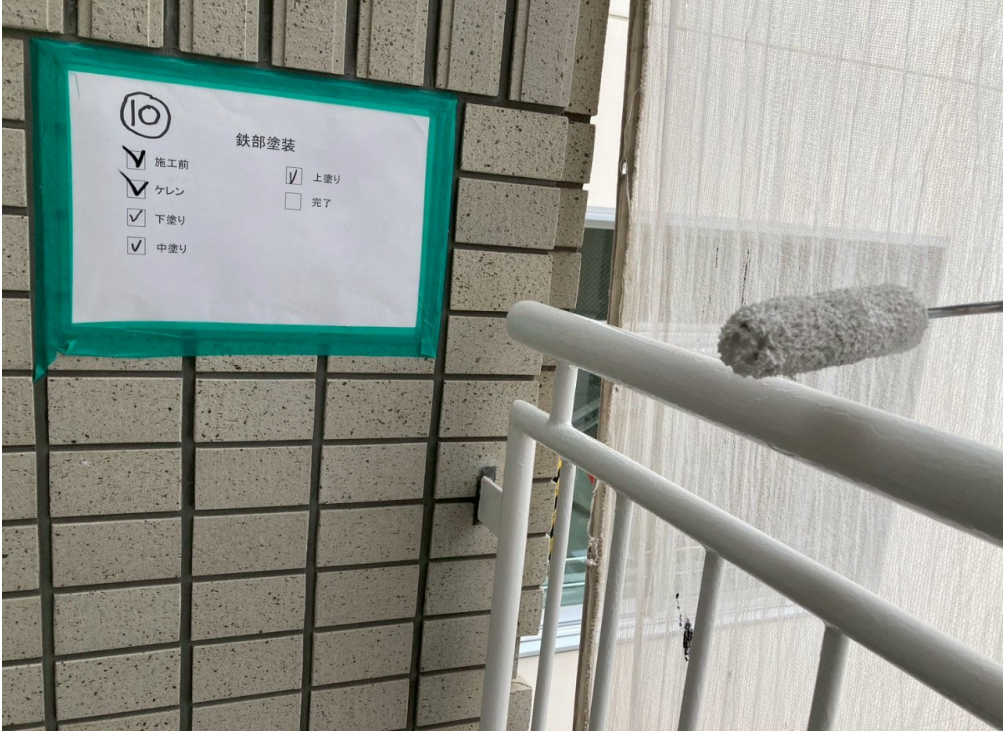
南面⑦	5	鉄柵部塗装	上塗

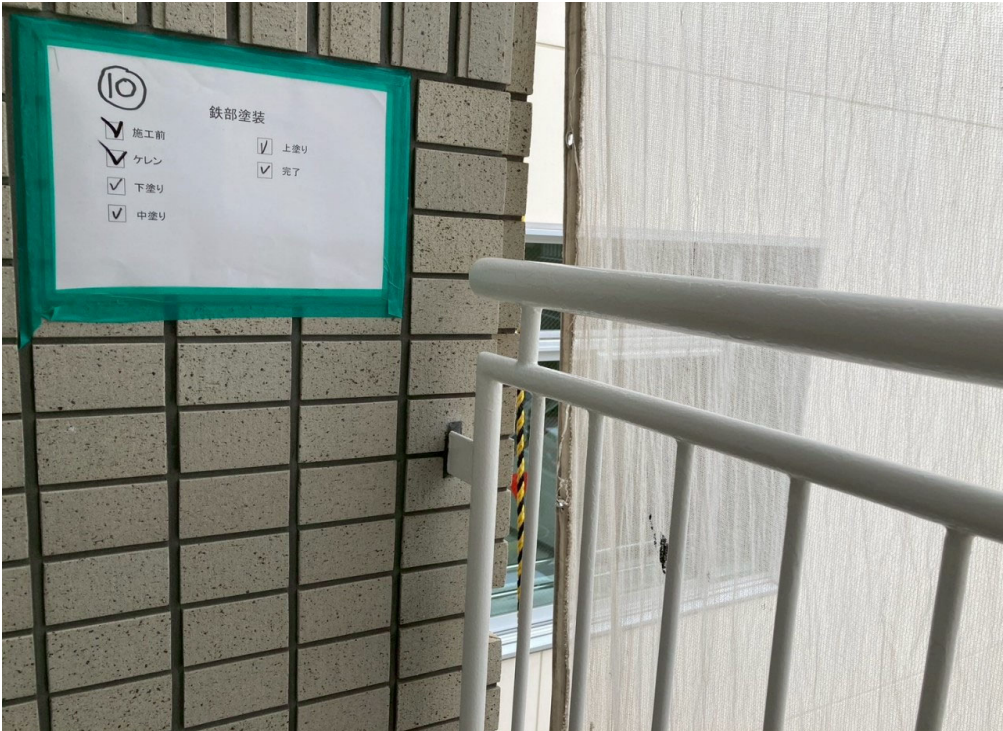
A photograph of a construction site. On the left, a brick wall has a white checklist with a green border. The checklist is titled '鉄部塗装' (Iron part painting) and includes the following items: '施工前' (Before work) with a checked box, 'ケレン' (Cleaning) with a checked box, '下塗り' (Primer) with a checked box, '中塗り' (Intermediate coat) with a checked box, '上塗り' (Top coat) with a checked box, and '完了' (Completed) with an unchecked box. A circular logo with the number '10' is in the top left corner. In the foreground, a white metal railing is being painted with a grey roller. A white mesh sheet is visible in the background.			
南面⑦	6	鉄柵部塗装	完了
